**Flood Control Project Maintenance
Levee Inspections**
LMA District Cover Sheet
Spring 2019 Levee Inspection Results

American River Flood Control District

Spring 2019 Levee Inspection Results

Waterway			Bank	Unit Miles
Unit No. 01 Arcade Creek			Left	2.08
	Spring (March - May)	Summer (June - August)	(September - November) Fall	Winter (December - February)
Unit Maintenance Rating (Fall Only)				
Date of Inspection	5/14/2019 - 5/14/2019			
DWR Inspector	Luz Dial			
Accompanied By	Ross Kawamura ARFCD

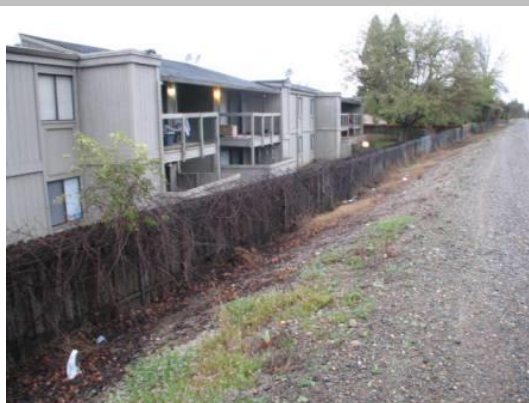
Photo 1 of 1 : SP_2019_NA0001_55_168_20190307_00147.jpg

LM Start	10.81	Rating **	U	Issue No.	168
LM End	10.83	Issue Type +	En	Location *	LS
Category	Earthen Levee			GPS Latitude/Longitude	
				Start	End
Item	Encroachments			38.565917 °	38.565646 °
				-121.351682 °	-121.351532 °
DWR ID	DWR_NA0001_04_s _ 2012_168				
Comment Code					
FE : Fence					
Inspector Comment					
Wooden privacy fence and vines within 10-ft of levee toe block visibility.

03/16/2012 Wood privacy fence completely obstructs access and visibility.

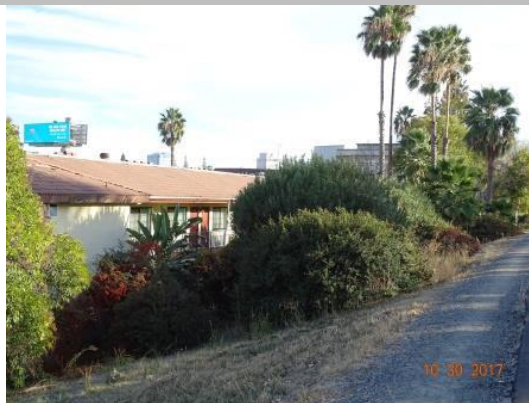
Photo 1 of 1 : SP_2019_NA0001_56_2_20190307_00002.jpg

LM Start	0.10	Rating **	U	Issue No.	2
LM End	0.17	Issue Type +	En	Location *	LS
Category	Earthen Levee			GPS Latitude/Longitude	
				Start	End
Item	Vegetation			38.595044 °	38.594117 °
				-121.506497 °	-121.506377 °
DWR ID	DWR_NA0001_05_s_2012_2				
Comment Code					
V6 : Landscaping					
Inspector Comment					
There is landscaping behind the Best Western. This appears to be permit 8760, but the landscaping is not maintained per Title 23 standards.

View of the landscaping on the landside levee slope obstructing visibility and access. Fall 2017

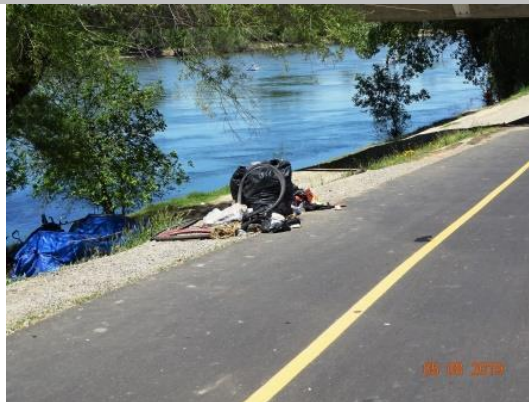
Photo 1 of 1 : SP_2019_NA0001_56_3_20190513_00003.jpg

LM Start	0.34	Rating **	M	Issue No.	3
LM End	0.34	Issue Type +	Ma	Location *	WS
Category	Earthen Levee			GPS Latitude/Longitude	
				Start	End
Item	Encroachments			38.591703 °	38.591703 °
				-121.505550 °	-121.505550 °
DWR ID	DWR_NA0001_05_s_2019_3				
Comment Code					
DE : Debris					
Inspector Comment					
Remove homeless debris on levee shoulder.

View looking upstream at homeless debris on levee shoulder. Spring 2019

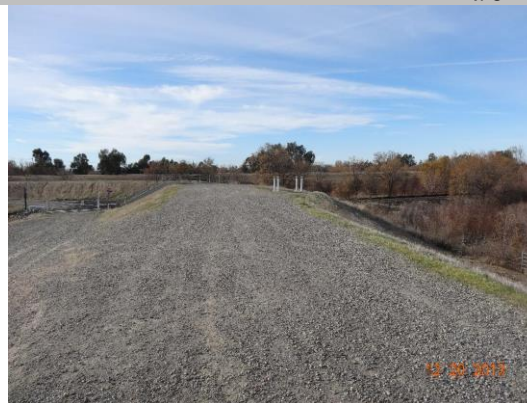
Photo 1 of 3 : UCIP_SP_2019_26884_49630.jpg

LM Start	0.02	Rating **	A/W	Issue No.	8
LM End	0.02	Issue Type +	Ma	Location *	
Category	Supplemental			GPS Latitude/Longitude	
				Start	End
Item	DWR UCIP LMA Responsibility			38.657400 °	38.657400 °
				-121.474455 °	-121.474455 °
DWR ID	24092				
Comment Code					
Inspector Comment					
FS_ID:26884 DS_ID:24092 EP_NO: N/A Repair Type: No Action Needed Crossing Status: Found UCIP Comments: FIELD_STRUCT_DESC: 24-inch corrugated metal (CM) drainage pipe through the levee, 22.7 feet below the crown. Two CM cutoff walls around pipe. Slide gate in 30-inch CM riser and flap gate at located on the waterside (WS) end. Concrete headwalls on both ends, WS and landside (LS). [Additional Reference(s): DWR Levee Log, 2002. USACE Sacramento O&M Manual Unit 118 Part 2, August 1959, Drawing No. 1-4-392 of Exhibit B, (Station 396+65)]. FS Date: 12/20/2013

View of levee crown at crossing.

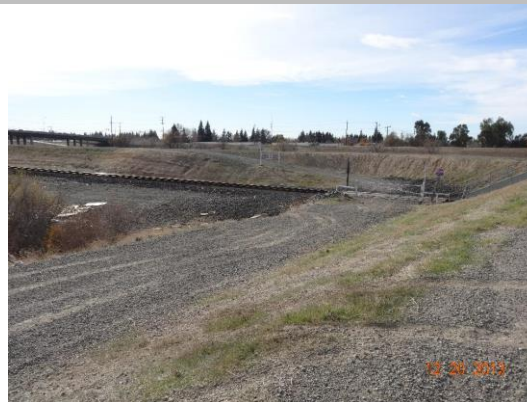
Photo 2 of 3 : UCIP_SP_2019_26884_49629.jpg

View of landward side.

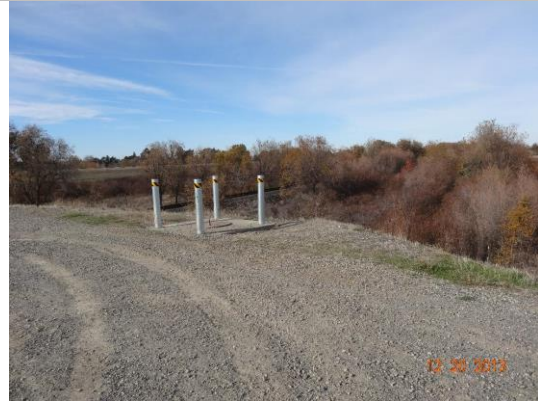
Photo 3 of 3 : UCIP_SP_2019_26884_49628.jpg

Comment Code						
Inspector Comment						
FS_ID:26884						
DS_ID:24092						
EP_NO: N/A						
Repair Type: No Action Needed						
Crossing Status: Found						
UCIP Comments:						
FIELD_STRUCT_DESC: 24-inch corrugated metal (CM) drainage pipe through the levee, 22.7 feet below the crown. Two CM cutoff walls around pipe. Slide gate in 30-inch CM riser and flap gate at located on the waterside (WS) end. Concrete headwalls on both ends, WS and landside (LS). [Additional Reference(s): DWR Levee Log, 2002. USACE Sacramento O&M Manual Unit 118 Part 2, August 1959, Drawing No. 1-4-392 of Exhibit B, (Station 396+65)].						
FS Date: 12/20/2013

Concrete vault protected by posts located on waterward shoulder.

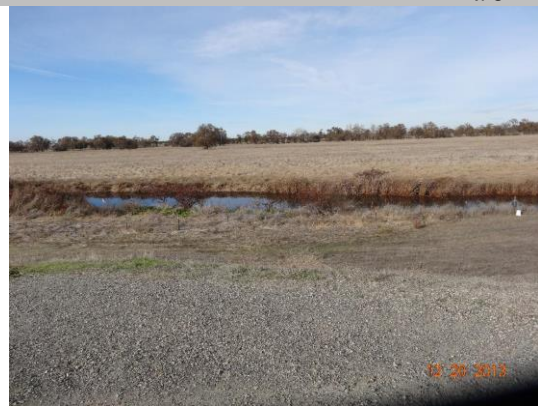
Photo 1 of 3 : UCIP_SP_2019_30706_56559.jpg

Comment Code						
Inspector Comment						
FS_ID:30706 DS_ID:24812 EP_NO: N/A Repair Type: Non-Urgent Crossing Status: Indicator Found UCIP Comments: 08/16/2017 DWR Deferred Maintenance Project (DMP), Vince Rodriguez, forwarded email received from Tim Kerr, General Manager of American River Flood Control District (ARFCD) with file "DWR Eligible Pipes Found in ARFCD" from ARFCD that shows the ownership and location of the pipes Tim Kerr investigated. Owner of this crossing is identified as the City of Sacramento, ARFCD Staff Notes indicate landside DI near Pinedale. (DWR UCIP - O. Magana) 12/20/2013 Unable to confirm if line goes through levee or along landward slope. No permit found. (DWR UCIP - O. Magana) FIELD_STRUCT_DESC: Storm drain manhole located on landside (LS). (no permit has been identified authorizing this structure, structure is owned by the City of Sacramento) FS Date: 12/20/2013

View of waterward side.

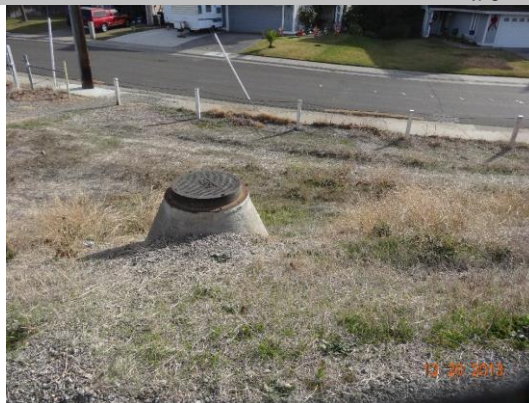
Photo 2 of 3 : UCIP_SP_2019_30706_56558.jpg

Manhole located on landward slope.

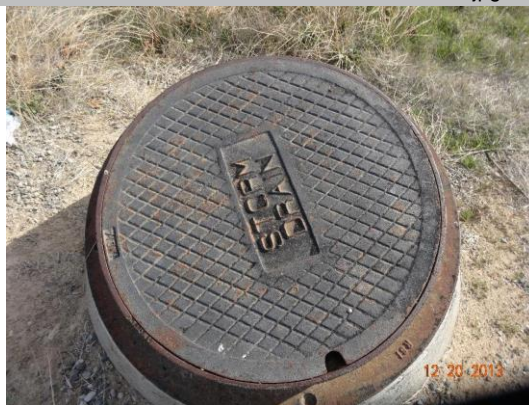
Photo 3 of 3 : UCIP_SP_2019_30706_56557.jpg

Manhole located on landward side identified as storm drain. Unable to determine if drain crosses levee.

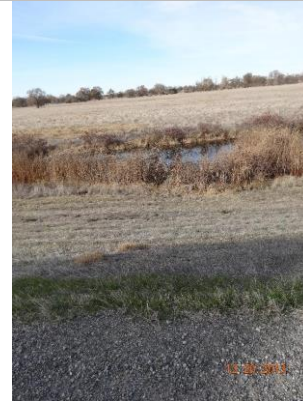
Photo 1 of 3 : UCIP_SP_2019_29223_54002.jpg

Comment Code						
Inspector Comment						
FS_ID:29223 DS_ID:24354 EP_NO: N/A Repair Type: Non-Urgent Crossing Status: Indicator Found UCIP Comments: 08/16/2017 DWR Deferred Maintenance Project (DMP), Vince Rodriguez, forwarded email received from Tim Kerr, General Manager of American River Flood Control District (ARFCD) with file "DWR Eligible Pipes Found in ARFCD" from ARFCD that shows the ownership and location of the pipes Tim Kerr investigated. Owner of this crossing was not identified, ARFCD Staff Notes indicate old pipe between Kelton and Sully (not found). (DWR UCIP - O. Magana) 12/20/2013 Unable to find CM riser and flap gate on waterward end--need to contact owner to determine status of crossing. Manhole found on landward side however unable to determine if manhole is part of this crossing. (DWR UCIP - O. Magana) FIELD_STRUCT_DESC: 24-inch corrugated metal drainage pipe through the levee, 12.5 feet below the crown. Two corrugated metal cutoff walls around pipe. Slide gate in corrugated metal riser and flap gate on waterside (WS) end. Concrete headwalls on both ends, WS and landside (LS). (no permit has been identified authorizing this structure - no owner has been identified) [Additional Reference(s): USACE Sacramento O&M Manual Unit 118 Part 2, August 1959, Drawing No. 1-4-392 of Exhibit B, (Station 440+50)]. FS Date: 12/20/2013

View of waterward side--no evidence of crossing.

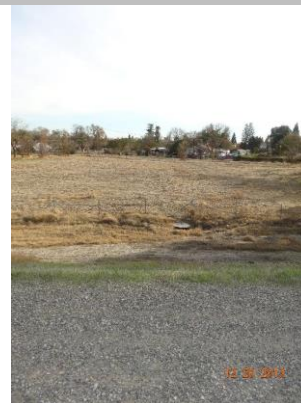
Photo 2 of 3 : UCIP_SP_2019_29223_54001.jpg

View of landward side--manhole on landward toe.

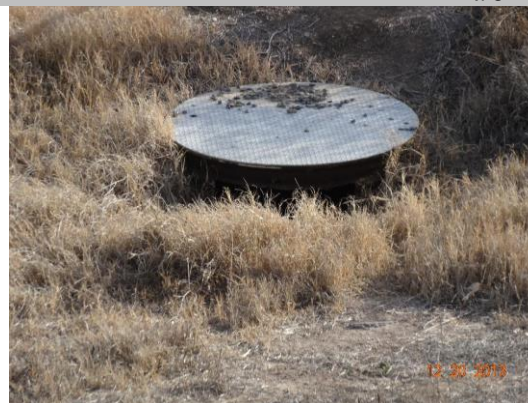
Photo 3 of 3 : UCIP_SP_2019_29223_54000.jpg

Manhole visible on landward toe.

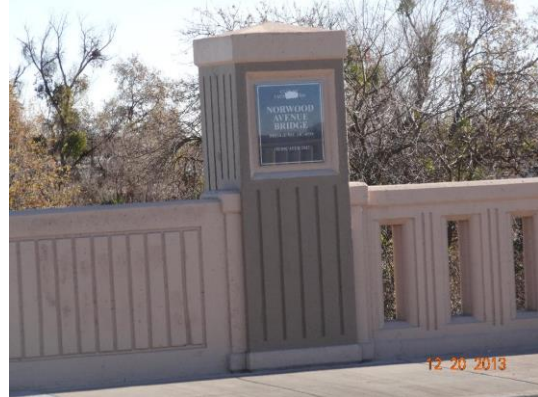
Photo 1 of 3 : UCIP_SP_2019_53489_54061.jpg

FS_ID:53489
DS_ID:24363
EP_NO: 18641-1
Repair Type: Non-Urgent
Crossing Status: Found
UCIP Comments: 07/18/2018 Everything appears to be the same as last time. No markers have been placed. This gas line is supposed to be raised to the 200-year water surface elevation. PG&E records for this distribution main indicate that there were no leaks found on the 06/2017 leak survey and the pipeline is operating correctly according to the 12/2016 CP inspection. Crossing is downgraded to "Non-Urgent" until the gas line is raised to the 200-year level. (A. McDonald - DWR UCIP)08/11/2016 Markers still missing. LMA representatives, Tim Kerr and Richard Marck, provided permit for PG&E line to be raised to 200-year water surface elevation. Pipe will be raised on both the right and left banks. Depth below the crown will need to be updated once construction is completed. (DWR UCIP - omagana)12/19/2013 Missing gas line markers -- need to contact owner to determine status. (DWR UCIP - omagana)

Norwood Avenue Bridge

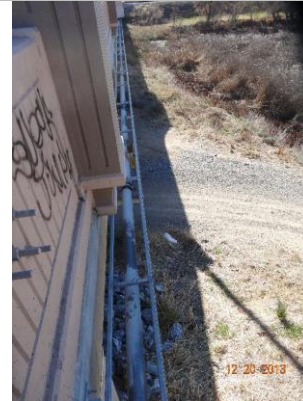
Photo 2 of 3 : UCIP_SP_2019_53489_54062.jpg

View of pipe attached to bridge.

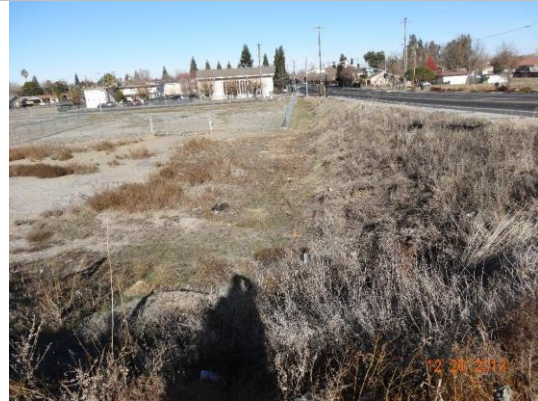
Photo 3 of 3 : UCIP_SP_2019_53489_54060.jpg

View of LS.

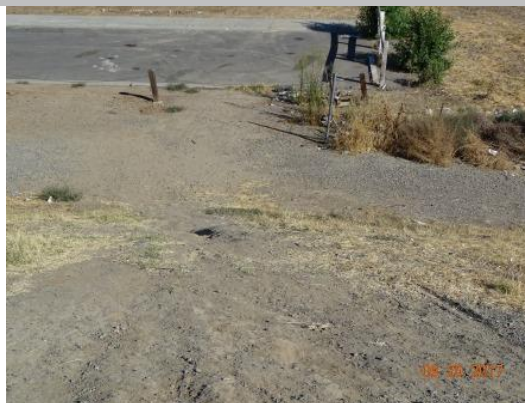
Photo 1 of 1 : SP_2019_NA0001_58_5_20190307_00004.jpg

LM Start	1.05	Rating **	A/W	Issue No.	5
LM End	1.05	Issue Type +	Ma	Location *	LS
Category	Earthen Levee			GPS Latitude/Longitude	
				Start	End
Item	Slope Stability			38.625862 °	38.625862 °
				-121.450978 °	-121.450978 °
DWR ID	DWR_NA0001_07_f_2017_5				
Comment Code					
S2 : Repair the levee slope damaged by foot traffic and prevent access where possible.					
Inspector Comment					
Erosion was not visible during this inspection.

View of the damaged levee slope.

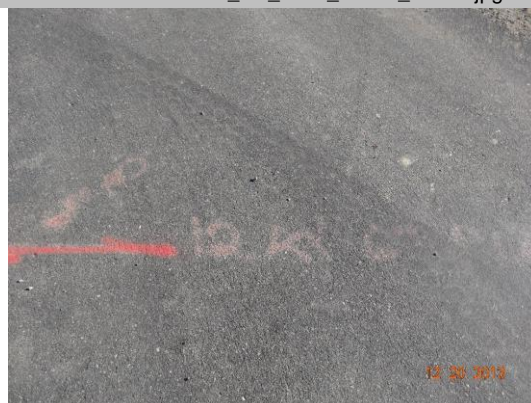
Photo 3 of 3 : UCIP_SP_2019_40803_48510.jpg

Comment Code						
Inspector Comment						
FS_ID:40803 DS_ID:24447 EP_NO: 16466 Repair Type: Non-Urgent Crossing Status: Found UCIP Comments: 06/14/2017 This crossing is scheduled to be cut and replaced as part of Sacramento Area Flood Control (SAFCA) North Area Streams (NAS) Levee Improvement Project: City of Sacramento Utility Permit Modifications Along Arcade Creek Levees. Unable to confirm when pipe will be replaced. Need to coordinate with owner and DWR FPIIB Inspector to determine when project is expected to start. (DWR UCIP - O. Magana). 12/20/2013 Need to contact owner to determine if crossings are at this location are associated with Permit number 16466--unable to confirm crossings. (DWR UCIP - O. Magana) FIELD_STRUCT_DESC: Two 6-inch and one 2-inch concrete encased steel utility conduits through the levee, all approximately 2 feet below the crown. Manhole located on the levee crown. (two 6-inch pipes and one 2-inch pipe authorized under Permit No. 16466, 1995 - Sacramento Municipal Utility District [SMUD]; modifications to existing crossings, cut and replace existing two 6-inch pipes and one 2-inch pipe, work authorized under Permit No. 16466, 2016 - SMUD) FS Date: 12/20/2013

Underground Service Alert (USA) faint utility markers visible on levee crown.

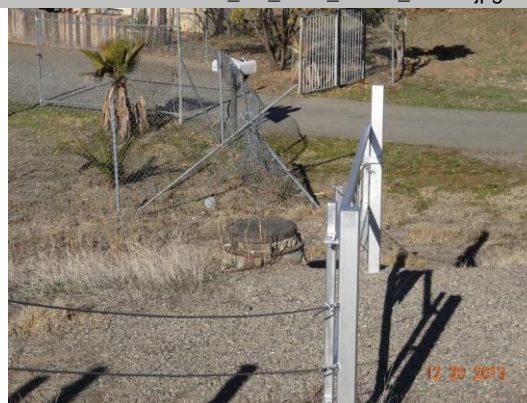
Photo 1 of 1 : UCIP_SP_2019_29275_54199.jpg

LM Start	1.31	Rating **	M	Issue No.	51
LM End	1.31	Issue Type +	En	Location *	
Category	Supplemental			GPS Latitude/Longitude	
				Start	End
Item	DWR UCIP Field Study			38.626198 °	38.626198 °
				-121.446321 °	-121.446321 °
DWR ID	24553				
Comment Code					
Inspector Comment					
FS_ID:29275 DS_ID:24553 EP_NO: N/A Repair Type: Non-Urgent Crossing Status: Found UCIP Comments: Only manhole present--need to coordinate with owner to determine if crossing is still presnt and whether manhole corresponds to this crossing. FIELD_STRUCT_DESC: 8-inch (not 10-inch as indicated in desk study) sewer pipe through the levee, 7.5 feet below the crown. Floodgates within the levee across the channel, installed under Permit No. 14480 (1986) by the City of Sacramento, Department of Public Works. [Additional Reference(s): DWR Levee Log, 2002] FS Date: 12/20/2013

Manhole visible on landward side.

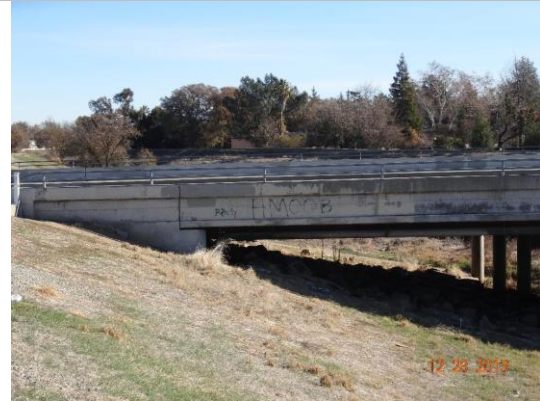
Photo 1 of 3 : UCIP_SP_2019_53491_75853.jpg

FS_ID:53491
DS_ID:24443
EP_NO: 15152-1
Repair Type: Non-Urgent
Crossing Status: Found
UCIP Comments: 07/18/2018 This pipeline was abandoned. It was cut and capped at the north end of the Rio Linda Blvd bridge. The section of pipe that goes under the levee is open on the WS end. This gas line is supposed to be raised to the 200-year water surface elevation. PG&E records for this distribution main indicate that there were no leaks found on the 07/2017 leak survey and the pipeline is operating correctly according to the 12/2016 CP inspection. Crossing downgraded to "Non-Urgent" pending documentation that this gas line has been abandoned properly. (A. McDonald - DWR UCIP)8/11/2016 Markers still missing. Will need to update depth below crown once construction is completed. (DWR UCIP - omagana)12/20/2013 Unable to confirm if crossing is the same one authorized through permit. (DWR UCIP - omagana) FIELD_STRUCT_DESC: *ABANDONED* 4-inch steel natural gas main through the levee, 2.5 feet below the crown. Vent on the waterside (WS) shoulder. Pipeline was abandoned, cut, and capped at the north end of the Rio Linda Blvd bridge. In case of an emergency related to this pipeline, PG&E has identified the following contacts: PG&E's local pipeline engineer, Mike Aronoff at 916-307-9472 (cell), and Gas Control (north) at 800-442-4743. For non-emergency issues, please contact the local PG&E Gas Pipeline Operations and Maintenance (GPOM) supervisors for the Sacramento region, David Wade at 209-639-1039 (cell), or Ron Hicks at 916-396-9038 (cell). (4-inch line installed under Permit No. 15152, 1989 - Pacific Gas and Electric Company [PG&E]; 4-inch will be raised above the 200-year water surface elevation within the levee crown under Permit No. 15152-1, 2016 - PG&E).

View of WS.

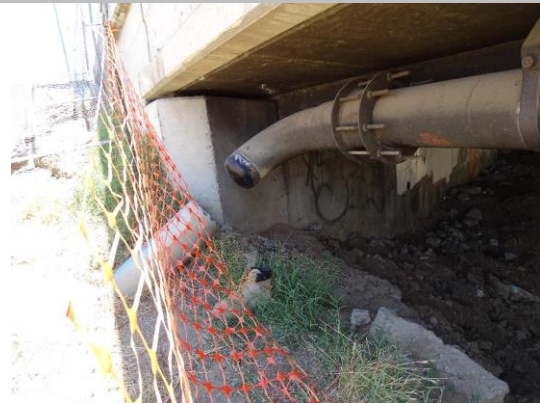
Photo 3 of 3 : UCIP_SP_2019_53491_77630.jpg

Comment Code						
Inspector Comment						
FS_ID:53491 DS_ID:24443 EP_NO: 15152-1 Repair Type: Non-Urgent Crossing Status: Found UCIP Comments: 07/18/2018 This pipeline was abandoned. It was cut and capped at the north end of the Rio Linda Blvd bridge. The section of pipe that goes under the levee is open on the WS end. This gas line is supposed to be raised to the 200-year water surface elevation. PG&E records for this distribution main indicate that there were no leaks found on the 07/2017 leak survey and the pipeline is operating correctly according to the 12/2016 CP inspection. Crossing downgraded to "Non-Urgent" pending documentation that this gas line has been abandoned properly. (A. McDonald - DWR UCIP)8/11/2016 Markers still missing. Will need to update depth below crown once construction is completed. (DWR UCIP - omagana)12/20/2013 Unable to confirm if crossing is the same one authorized through permit. (DWR UCIP - omagana) FIELD_STRUCT_DESC: *ABANDONED* 4-inch steel natural gas main through the levee, 2.5 feet below the crown. Vent on the waterside (WS) shoulder. Pipeline was abandoned, cut, and capped at the north end of the Rio Linda Blvd bridge. In case of an emergency related to this pipeline, PG&E has identified the following contacts: PG&E's local pipeline engineer, Mike Aronoff at 916-307-9472 (cell), and Gas Control (north) at 800-442-4743. For non-emergency issues, please contact the local PG&E Gas Pipeline Operations and Maintenance (GPOM) supervisors for the Sacramento region, David Wade at 209-639-1039 (cell), or Ron Hicks at 916-396-9038 (cell). (4-inch line installed under Permit No. 15152, 1989 - Pacific Gas and Electric Company [PG&E]; 4-inch will be raised above the 200-year water surface elevation within the levee crown under Permit No. 15152-1, 2016 - PG&E). FS Date: 7/18/2018

Natural gas pipeline grouted and capped on the WS at N end of Rio Linda Blvd bridge.

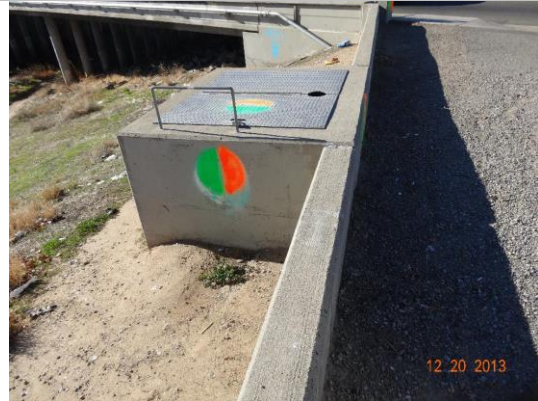
Photo 3 of 3 : UCIP_SP_2019_29301_54276.jpg

Comment Code						
Inspector Comment						
FS_ID:29301 DS_ID:24370 EP_NO: N/A Repair Type: No Action Needed Crossing Status: Found UCIP Comments: 08/16/2017 DWR Deferred Maintenance Project (DMP), Vince Rodriguez, forwarded email received from Tim Kerr, General Manager of American River Flood Control District (ARFCD) with file "DWR Eligible Pipes Found in ARFCD" from ARFCD that shows the ownership and location of the pipes Tim Kerr investigated. Owner of this crossing is identified as the City of Sacramento, ARFCD Staff Notes indicate Arcade CK just upstream of Rio Linda. (DWR UCIP - O. Magana) FIELD_STRUCT_DESC: 24-inch corrugated metal (CM) drainage pipe through the levee, 11 feet below the crown. Slide gate in CM riser on the waterside (WS) slope. Flap gate on the WS end. Concrete headwalls on both ends, WS and landside (LS). (no permit has been identified authorizing this structure, structure is owned by the City of Sacramento) [Additional Reference(s): DWR Levee Log, 2002. USACE Sacramento O&M Manual Unit 118, Part No. 2, October 1959, Drawing No. 1-4-392 Exhibit B, (Station 65+73)] FS Date: 12/20/2013

Concrete vault located on waterward shoulder.

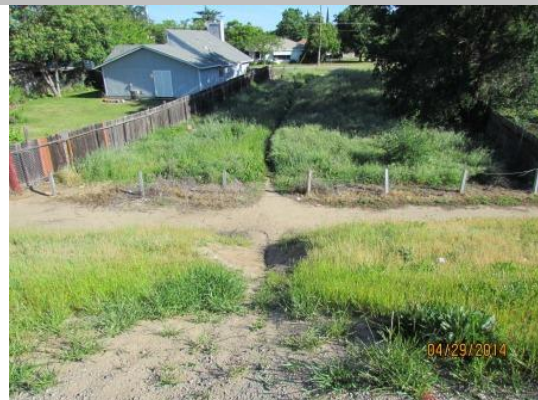
Photo 1 of 1 : SP_2019_NA0001_58_34_20190307_00029.jpg

LM Start	1.39	Rating **	A/W	Issue No.	34
LM End	1.39	Issue Type +	Ma	Location *	LS
Category	Earthen Levee			GPS Latitude/Longitude	
				Start	End
Item	Slope Stability			38.626601 °	38.626601 °
				-121.445016 °	-121.445016 °
DWR ID	DWR_NA0001_07_s_2012_34				
Comment Code					
S2 : Repair the levee slope damaged by foot traffic and prevent access where possible.					
Inspector Comment					
The erosion of the levee slope from the footpath appears to be stable at this time and should be monitored.

View of the landside levee slope damaged by foot traffic.

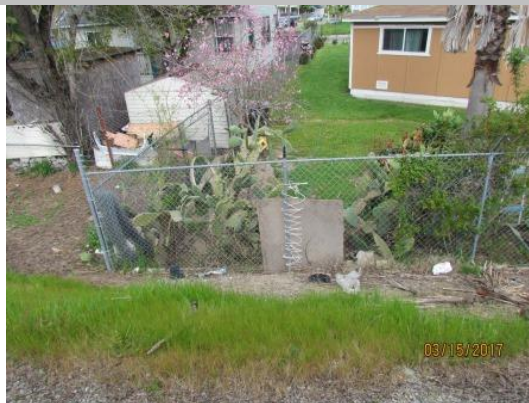
Photo 1 of 1 : SP_2019_NA0001_58_8_20190307_00007.jpg

LM Start	1.50	Rating **	M	Issue No.	8
LM End	1.50	Issue Type +	En	Location *	LS
Category	Earthen Levee			GPS Latitude/Longitude	
				Start	End
Item	Encroachments			38.627526 °	38.627526 °
				-121.443310 °	-121.443310 °
DWR ID	DWR_NA0001_07_s_2013_8				
Comment Code					
FE : Fence					
Inspector Comment					
Vegetation growing on fence is blocking visibility.

View of the fence obstruction visibility and access at the landside levee toe. Spring 2017.

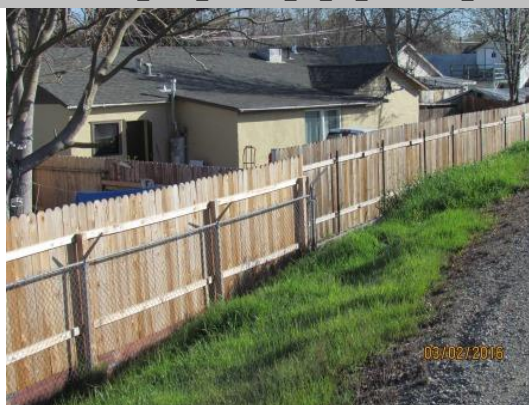
Photo 1 of 1 : SP_2019_NA0001_58_37_20190307_00030.jpg

LM Start	1.52	Rating **	U	Issue No.	37
LM End	1.52	Issue Type +	En	Location *	LS
Category	Earthen Levee			GPS Latitude/Longitude	
				Start	End
Item	Encroachments			38.627655 °	38.627655 °
				-121.442974 °	-121.442974 °
DWR ID	DWR_NA0001_07_s_2016_37				
Comment Code					
FE : Fence					
Inspector Comment

View of the fence at the landside levee toe.

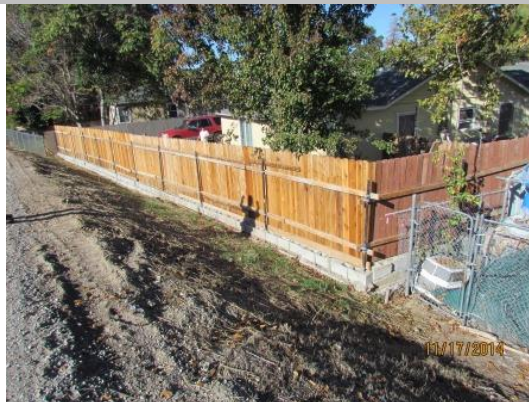
Photo 1 of 1 : SP_2019_NA0001_58_43_20190307_00035.jpg

LM Start	1.53	Rating **	U	Issue No.	43
LM End	1.54	Issue Type +	En	Location *	LS
Category	Earthen Levee			GPS Latitude/Longitude	
				Start	End
Item	Encroachments			38.627675 °	38.627718 °
				-121.442874 °	-121.442631 °
DWR ID	DWR_NA0001_07_s_2014_43				
Comment Code					
FE : Fence					
Inspector Comment					
New fence constructed on the property line with 18 inch CMU block base.

View of a fence at the landside levee toe obstructing visibility and access.

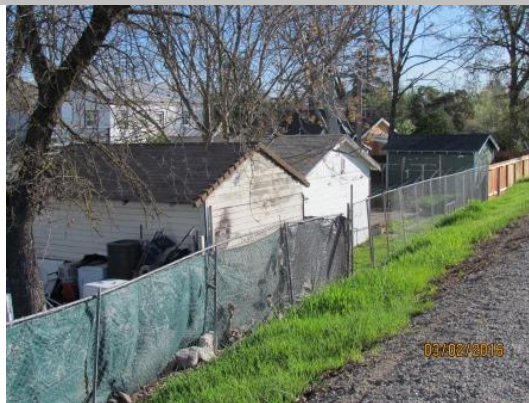
Photo 1 of 1 : SP_2019_NA0001_58_30_20190307_00027.jpg

LM Start	1.55	Rating **	U	Issue No.	30
LM End	1.55	Issue Type +	En	Location *	LS
Category	Earthen Levee			GPS Latitude/Longitude	
				Start	End
Item	Encroachments			38.627743 °	38.627743 °
				-121.442526 °	-121.442526 °
DWR ID	DWR_NA0001_07_s_2012_30				
Comment Code					
BU : Building					
Inspector Comment					
Large side building is within 10-ft of the levee toe.

View of the building at the landside levee toe.

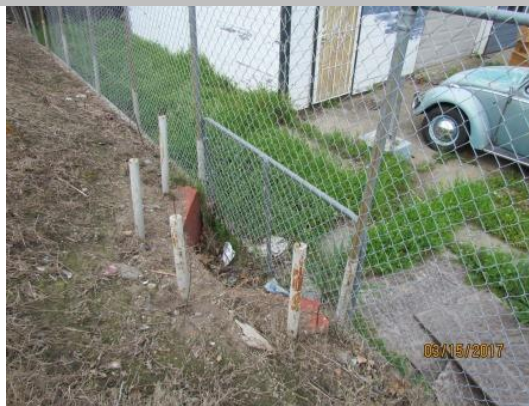
Photo 1 of 1 : SP_2019_NA0001_58_39_20190307_00032.jpg

LM Start	1.56	Rating **	M	Issue No.	39
LM End	1.56	Issue Type +	En	Location *	LS
Category	Earthen Levee			GPS Latitude/Longitude	
				Start	End
Item	Encroachments			38.627764 °	38.627764 °
				-121.442317 °	-121.442317 °
DWR ID	DWR_NA0001_07_s_2017_39				
Comment Code					
RW : Retaining Wall					
Inspector Comment					
4' retaining wall on levee toe.

View of the retaining wall into the levee prism.

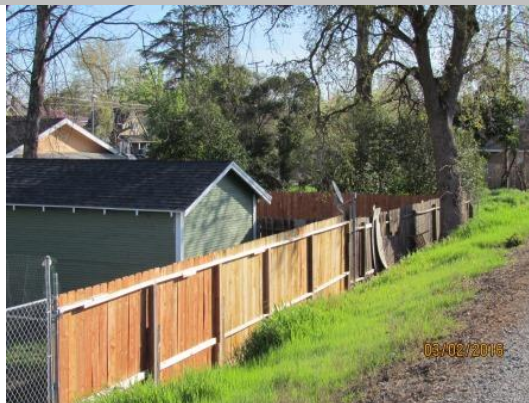
Photo 1 of 1 : SP_2019_NA0001_58_3_20190307_00002.jpg

LM Start	1.57	Rating **	U	Issue No.	3
LM End	1.57	Issue Type +	En	Location *	LS
Category	Earthen Levee			GPS Latitude/Longitude	
				Start	End
Item	Encroachments			38.627768 °	38.627768 °
				-121.442185 °	-121.442185 °
DWR ID	DWR_NA0001_07_s_2012_3				
Comment Code					
FE : Fence					
Inspector Comment					
Wooden privacy fence is within 10-ft of the levee toe.

Wooden privacy fence is constructed at the landside levee toe.

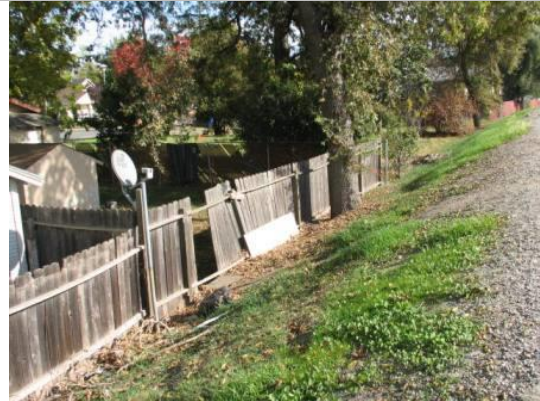
Photo 1 of 1 : SP_2019_NA0001_58_4_20190307_00003.jpg

LM Start	1.58	Rating **	U	Issue No.	4
LM End	1.58	Issue Type +	En	Location *	LS
Category	Earthen Levee			GPS Latitude/Longitude	
				Start	End
Item	Encroachments			38.627707 °	38.627707 °
				-121.441965 °	-121.441965 °
DWR ID	DWR_NA0001_07_s_2012_4				
Comment Code					
FE : Fence					
Inspector Comment					
Wooden privacy fence is within 10-ft of the levee toe.

11/17/2011 Wooden privacy fence is constructed at the toe.

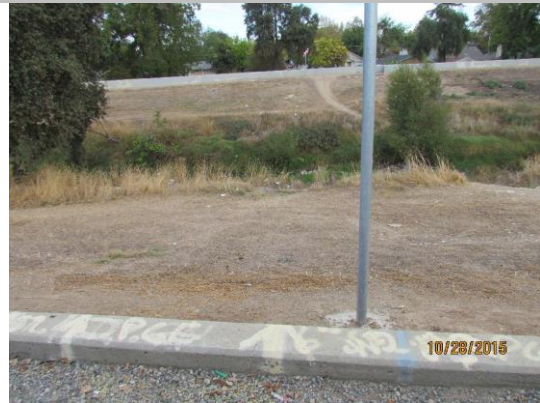
Photo 1 of 3 : UCIP_SP_2019_52672_74733.jpg

Comment Code					
Inspector Comment					
FS_ID:52672 DS_ID:24835 EP_NO: N/A Repair Type: Non-Urgent Crossing Status: Indicator Found UCIP Comments: 08/11/2017 PG&E records for DFM 0614-13 indicate that there were no observations found on the 07/2017 patrol, no leaks found on the 04/2017 leak survey, and the pipeline is operating correctly according to the 11/2016 CP inspection. (DWR UCIP - A. McDonald)11/12/15 Markers have been installed on both levees--confirmed during 2015 DWR Fall Inspection. Need to coordinate with PG&E to determine permit for this crossing.12/19/13 Gas line - no markers visible. No permit available. FIELD_STRUCT_DESC: 2 of 2: 6-inch gasline of unknown material through the levee and under the channel at an unknown depth. In case of an emergency related to this pipeline, PG&E has identified the following contacts: PG&E's local pipeline engineer, Mike Aronoff at 916-307-9472 (cell), and Gas Control (north) at 800-442-4743. For non-emergency issues, please contact the local PG&E Gas Pipeline Operations and Maintenance (GPOM) supervisors for the Sacramento region, David Wade at 209-639-1039 (cell), or Ron Hicks at 916-396-9038 (cell). FS Date: 12/20/2013

Markers installed through both levees in 2015.

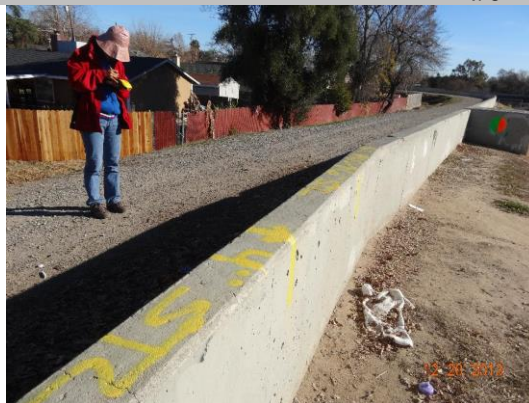
Photo 2 of 3 : UCIP_SP_2019_52672_57525.jpg

Underground service alert (USA) markings visible on floodwall.

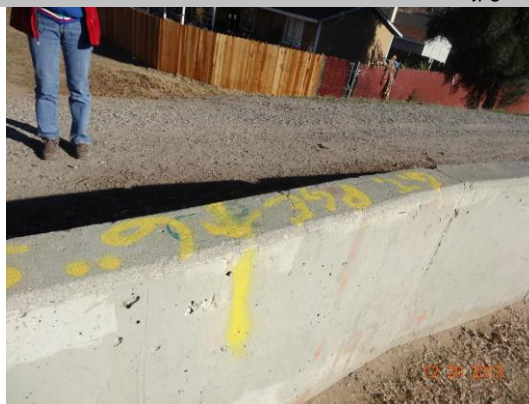
Photo 3 of 3 : UCIP_SP_2019_52672_57524.jpg

6-inch gas line through levee at an unknown depth.

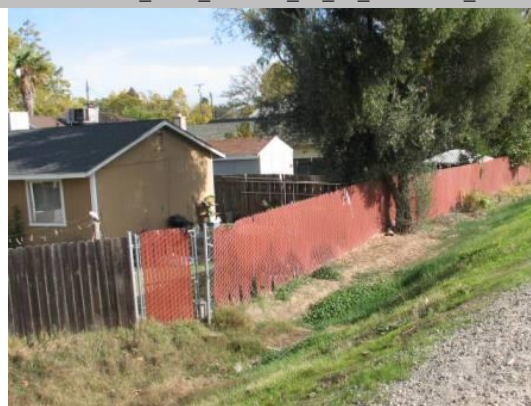
Photo 1 of 1 : SP_2019_NA0001_58_29_20190307_00026.jpg

LM Start	1.61	Rating **	M	Issue No.	29
LM End	1.61	Issue Type +	En	Location *	LS
Category	Earthen Levee			GPS Latitude/Longitude	
				Start	End
Item	Encroachments			38.627733 °	38.627733 °
				-121.441415 °	-121.441415 °
DWR ID	DWR_NA0001_07_s _ 2012_29				
Comment Code					
FE : Fence					
Inspector Comment					
Privacy fence is within 10-ft of the levee toe.

11/17/2011 Privacy fence is constructed at the toe.

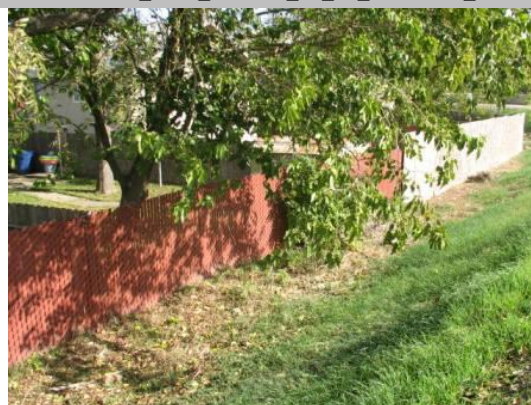
Photo 1 of 1 : SP_2019_NA0001_58_27_20190307_00024.jpg

LM Start	1.63	Rating **	U	Issue No.	27
LM End	1.63	Issue Type +	En	Location *	LS
Category	Earthen Levee			GPS Latitude/Longitude	
				Start	End
Item	Encroachments			38.627681 °	38.627681 °
				-121.441021 °	-121.441021 °
DWR ID	DWR_NA0001_07_s _ 2012_27				
Comment Code					
FE : Fence					
Inspector Comment					
Privacy fence and overgrown trees are within 10-ft of the levee toe.

11/17/2011 Privacy fence is constructed at the toe.

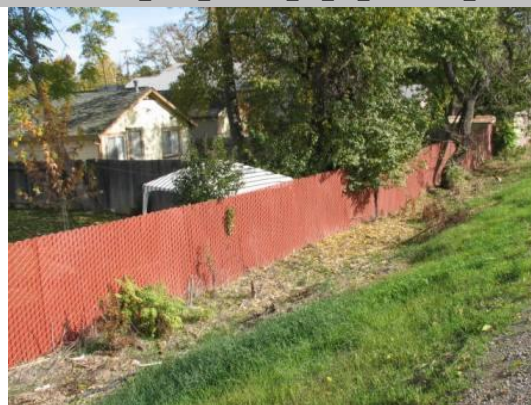
Photo 1 of 1 : SP_2019_NA0001_58_28_20190307_00025.jpg

LM Start	1.63	Rating **	M	Issue No.	28
LM End	1.63	Issue Type +	En	Location *	LS
Category	Earthen Levee			GPS Latitude/Longitude	
				Start	End
Item	Encroachments			38.627668 °	38.627668 °
				-121.441018 °	-121.441018 °
DWR ID	DWR_NA0001_07_s _ 2012_28				
Comment Code					
FE : Fence					
Inspector Comment					
Privacy fence is within 10-ft of the levee toe.

11/17/2011 Privacy fence is constructed at the toe.

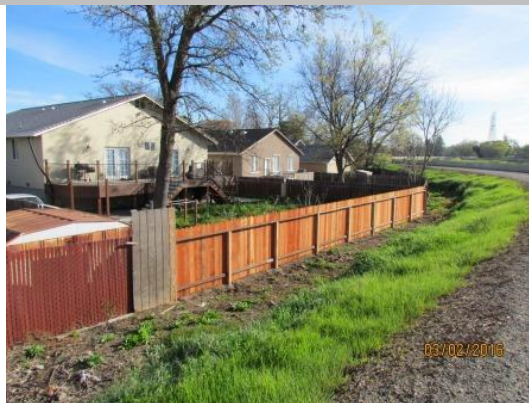
Photo 1 of 1 : SP_2019_NA0001_58_26_20190307_00023.jpg

LM Start	1.64	Rating **	U	Issue No.	26
LM End	1.64	Issue Type +	En	Location *	LS
Category	Earthen Levee			GPS Latitude/Longitude	
				Start	End
Item	Encroachments			38.627667 °	38.627667 °
				-121.440837 °	-121.440837 °
DWR ID	DWR_NA0001_07_s_2012_26				
Comment Code					
FE : Fence					
Inspector Comment					
Wooden privacy fence is within 10-ft of the levee toe.

View of the wooden fence at the landside levee toe.

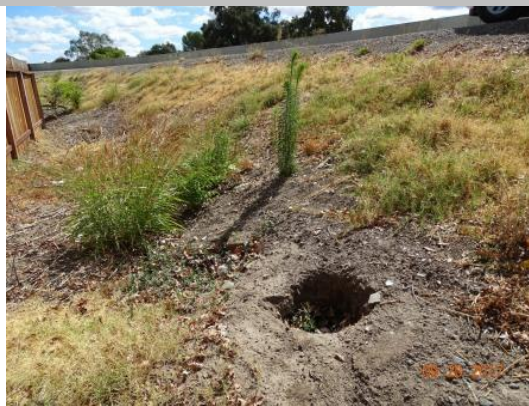
Photo 1 of 1 : SP_2019_NA0001_58_18_20190307_00017.jpg

LM Start	1.64	Rating **	M	Issue No.	18
LM End	1.64	Issue Type +	Ma	Location *	LS
Category	Earthen Levee			GPS Latitude/Longitude	
				Start	End
Item	Animal Control			38.627670 °	38.627670 °
				-121.440814 °	-121.440814 °
DWR ID	DWR_NA0001_07_f_2017_18				
Comment Code					
A3 : No rodents visible, but rodent burrows visible; need to backfill and compact or grout burrows.					
Inspector Comment

View of the rodent hole that needs to be backfilled.

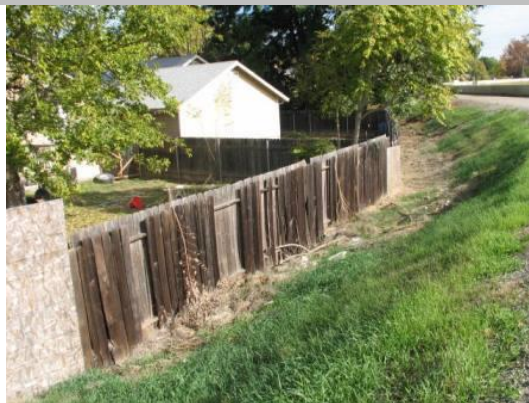
Photo 1 of 1 : SP_2019_NA0001_58_25_20190307_00022.jpg

LM Start	1.65	Rating **	U	Issue No.	25
LM End	1.65	Issue Type +	En	Location *	LS
Category	Earthen Levee			GPS Latitude/Longitude	
				Start	End
Item	Encroachments			38.627677 °	38.627677 °
				-121.440629 °	-121.440629 °
DWR ID	DWR_NA0001_07_s_2012_25				
Comment Code					
FE : Fence					
Inspector Comment					
Wooden privacy fence is within 10-ft of the levee toe.

11/17/2011 Wooden privacy fence is constructed at the toe.

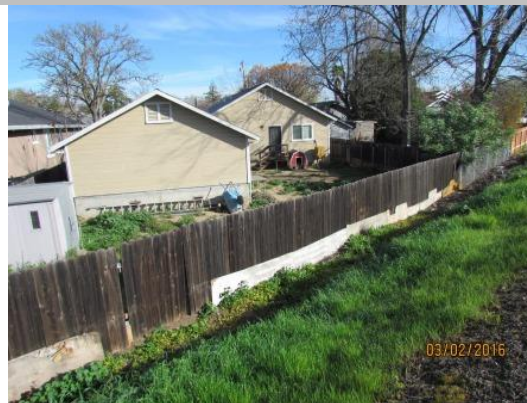
Photo 1 of 1 : SP_2019_NA0001_58_40_20190307_00033.jpg

LM Start	1.66	Rating **	U	Issue No.	40
LM End	1.66	Issue Type +	En	Location *	LS
Category	Earthen Levee			GPS Latitude/Longitude	
				Start	End
Item	Encroachments			38.627727 °	38.627727 °
				-121.440442 °	-121.440442 °
DWR ID	DWR_NA0001_07_s_2016_40				
Comment Code					
FE : Fence					
Inspector Comment

View of the fence at the landside levee toe.

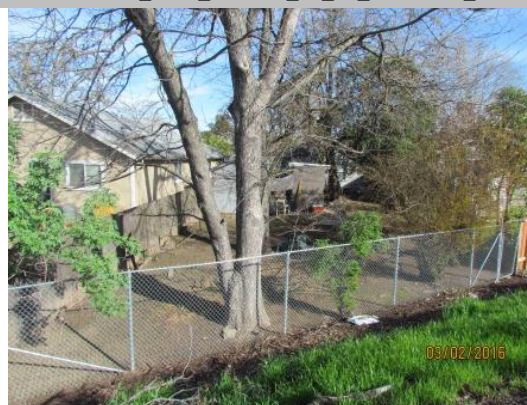
Photo 1 of 1 : SP_2019_NA0001_58_41_20190307_00034.jpg

LM Start	1.67	Rating **	M	Issue No.	41
LM End	1.67	Issue Type +	En	Location *	LS
Category	Earthen Levee			GPS Latitude/Longitude	
				Start	End
Item	Encroachments			38.627803 °	38.627803 °
				-121.440270 °	-121.440270 °
DWR ID	DWR_NA0001_07_s_2016_41				
Comment Code					
FE : Fence					
Inspector Comment

View of the fence at the landside levee toe.

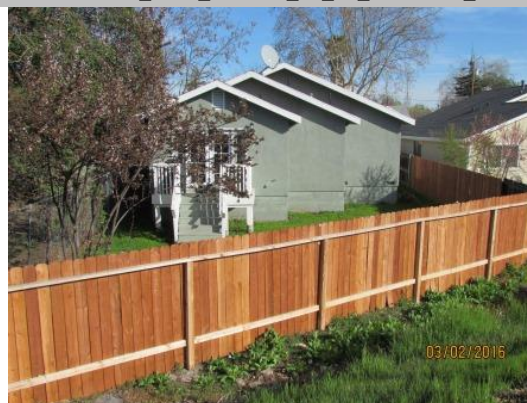
Photo 1 of 1 : SP_2019_NA0001_58_44_20190307_00036.jpg

LM Start	1.68	Rating **	U	Issue No.	44
LM End	1.68	Issue Type +	En	Location *	LS
Category	Earthen Levee			GPS Latitude/Longitude	
				Start	End
Item	Encroachments			38.627874 °	38.627874 °
				-121.440134 °	-121.440134 °
DWR ID	DWR_NA0001_07_s_2016_44				
Comment Code					
FE : Fence					
Inspector Comment

View of the fence at the landside levee toe.

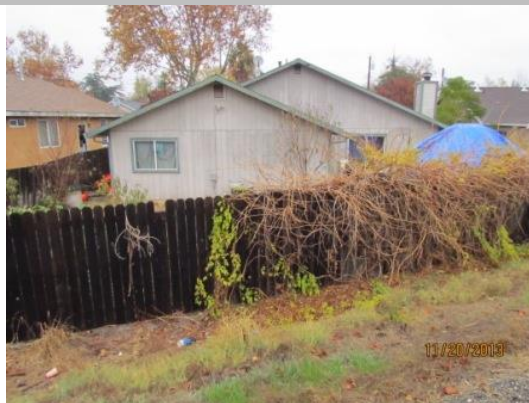
Photo 1 of 1 : SP_2019_NA0001_58_6_20190307_00005.jpg

LM Start	1.69	Rating **	U	Issue No.	6
LM End	1.69	Issue Type +	En	Location *	LS
Category	Earthen Levee			GPS Latitude/Longitude	
				Start	End
Item	Encroachments			38.627948 °	38.627948 °
				-121.439958 °	-121.439958 °
DWR ID	DWR_NA0001_07_s _ 2012_6				
Comment Code					
FE : Fence					
Inspector Comment					
Wooden privacy fence with vines are within 10-ft of the levee toe.

View of the wooden fence at the landside levee toe.

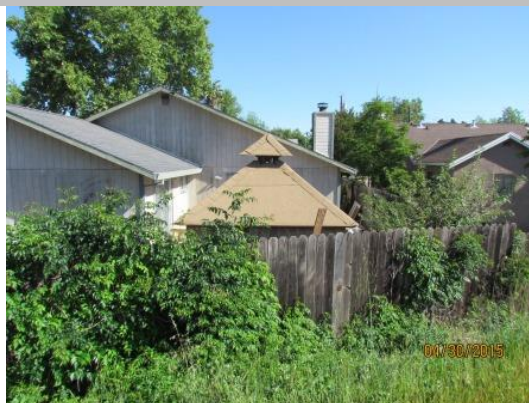
Photo 1 of 1 : SP_2019_NA0001_58_1_20190307_00001.jpg

LM Start	1.69	Rating **	U	Issue No.	1
LM End	1.69	Issue Type +	En	Location *	LS
Category	Earthen Levee			GPS Latitude/Longitude	
				Start	End
Item	Encroachments			38.627956 °	38.627956 °
				-121.439962 °	-121.439962 °
DWR ID	DWR_NA0001_07_s _ 2012_1				
Comment Code					
BU : Building					
Inspector Comment					
Construction of new structure is witin 15' of levee.

View of the shed at the landside levee toe.

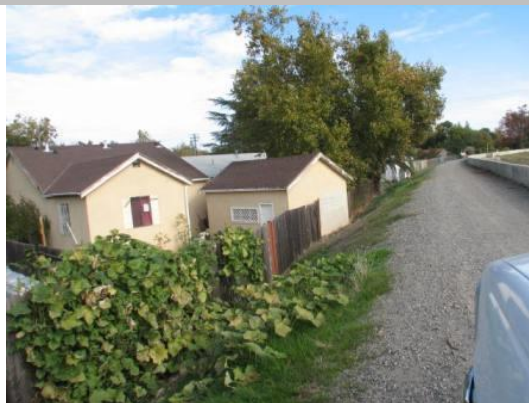
Photo 1 of 1 : SP_2019_NA0001_58_7_20190307_00006.jpg

LM Start	1.70	Rating **	U	Issue No.	7
LM End	1.70	Issue Type +	En	Location *	LS
Category	Earthen Levee			GPS Latitude/Longitude	
				Start	End
Item	Encroachments			38.627935 °	38.627935 °
				-121.439758 °	-121.439758 °
DWR ID	DWR_NA0001_07_s _ 2012_7				
Comment Code					
BU : Building					
Inspector Comment					
Corner of building protrudes into levee slope. Wooden fence is built on the levee slope.

11/17/2011 Building is constructed at the toe.

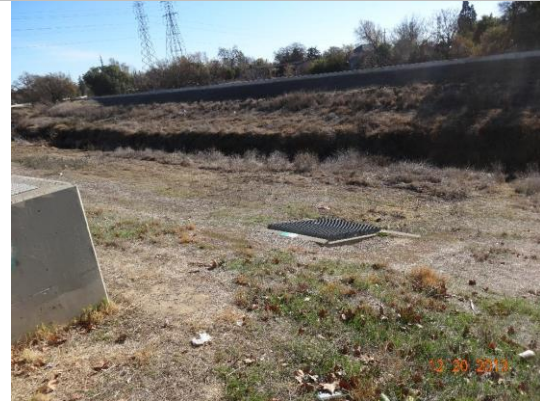
Photo 3 of 3 : UCIP_SP_2019_29324_54306.jpg

Concrete headwall with debris screen located on waterward toe.

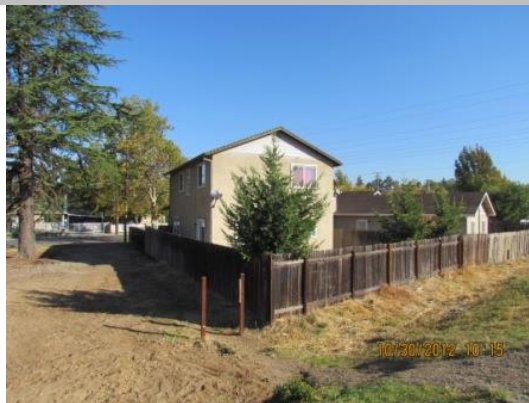
Photo 1 of 1 : SP_2019_NA0001_58_23_20190307_00020.jpg

LM Start	1.74	Rating **	U	Issue No.	23
LM End	1.74	Issue Type +	En	Location *	LS
Category	Earthen Levee			GPS Latitude/Longitude	
				Start	End
Item	Encroachments			38.628221 °	38.628221 °
				-121.439138 °	-121.439138 °
DWR ID	DWR_NA0001_07_s _ 2012_23				
Comment Code					
FE : Fence					
Inspector Comment					
Wooden fence and cedar trees are within 10-ft of levee toe.

View of wooden privacy fence constructed at the toe.

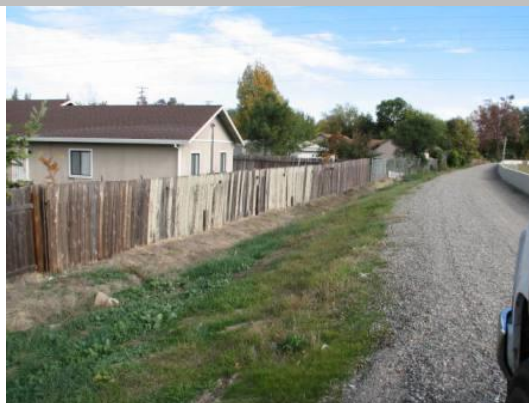
Photo 1 of 1 : SP_2019_NA0001_58_9_20190307_00008.jpg

LM Start	1.75	Rating **	U	Issue No.	9
LM End	1.75	Issue Type +	En	Location *	LS
Category	Earthen Levee			GPS Latitude/Longitude	
				Start	End
Item	Encroachments			38.628197 °	38.628197 °
				-121.438863 °	-121.438863 °
DWR ID	DWR_NA0001_07_s _ 2012_9				
Comment Code					
FE : Fence					
Inspector Comment					
Wooden privacy fence is within 10-ft of the levee toe.

11/17/2011 Wooden privacy fence is constructed at the toe.

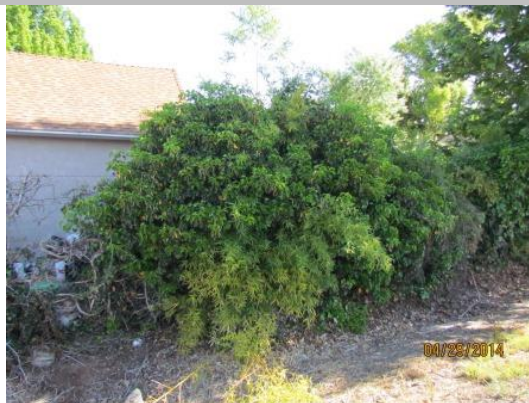
Photo 1 of 1 : SP_2019_NA0001_58_10_20190307_00009.jpg

LM Start	1.79	Rating **	U	Issue No.	10
LM End	1.79	Issue Type +	En	Location *	LS
Category	Earthen Levee			GPS Latitude/Longitude	
				Start	End
Item	Vegetation			38.628273 °	38.628273 °
				-121.438255 °	-121.438255 °
DWR ID	DWR_NA0001_07_s _ 2012_10				
Comment Code					
V6 : Landscaping					
Inspector Comment					
Ivy and other landscape plantings have grown up chain link fence on the levee toe. Building is within 10-ft of the levee toe. Prunings are on the levee slope.

Landscaping has grown over the fence and obstructs visibility and access.

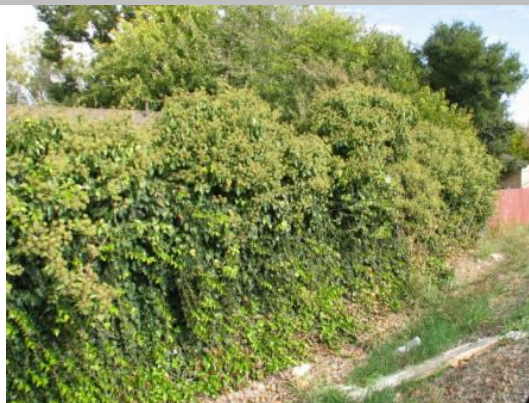
Photo 1 of 1 : SP_2019_NA0001_58_11_20190307_00010.jpg

LM Start	1.80	Rating **	U	Issue No.	11
LM End	1.80	Issue Type +	En	Location *	LS
Category	Earthen Levee			GPS Latitude/Longitude	
				Start	End
Item	Vegetation			38.628297 °	38.628297 °
				-121.437995 °	-121.437995 °
DWR ID	DWR_NA0001_07_f_2012_11				
Comment Code					
V6 : Landscaping					
Inspector Comment					
Dense ivy and landscaping planted on chain link fence are on levee toe. Porch and awning are within 10-ft of the levee toe.

11/17/2011 Overgrown vegetation obstructs visibility and access.

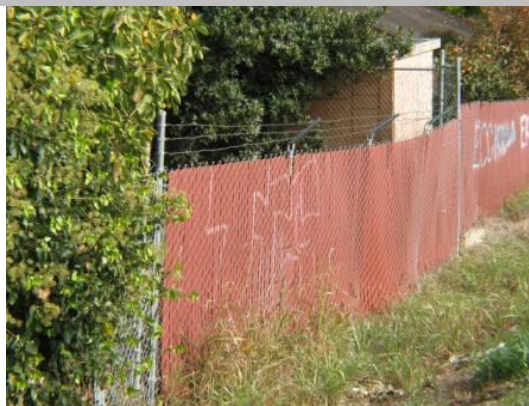
Photo 1 of 1 : SP_2019_NA0001_58_12_20190307_00011.jpg

LM Start	1.81	Rating **	U	Issue No.	12
LM End	1.81	Issue Type +	En	Location *	LS
Category	Earthen Levee			GPS Latitude/Longitude	
				Start	End
Item	Encroachments			38.628307 °	38.628307 °
				-121.437842 °	-121.437842 °
DWR ID	DWR_NA0001_07_s_2012_12				
Comment Code					
FE : Fence					
Inspector Comment					
Chain link privacy fence with barbed wire is within 10-ft of levee toe.

11/17/2011 Barbed wire topped privacy fence is located at the toe.

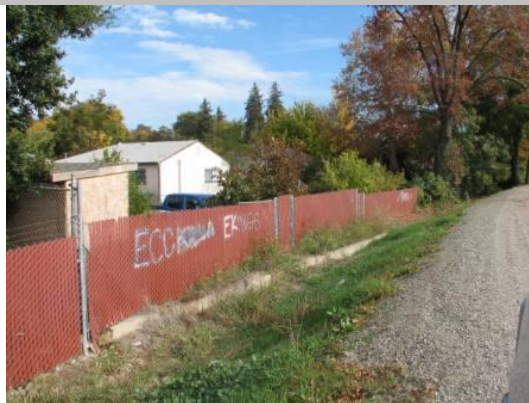
Photo 1 of 1 : SP_2019_NA0001_58_13_20190307_00012.jpg

LM Start	1.82	Rating **	U	Issue No.	13
LM End	1.82	Issue Type +	En	Location *	LS
Category	Earthen Levee			GPS Latitude/Longitude	
				Start	End
Item	Encroachments			38.628303 °	38.628303 °
				-121.437693 °	-121.437693 °
DWR ID	DWR_NA0001_07_s_2012_13				
Comment Code					
FE : Fence					
Inspector Comment					
Chain link privacy fence is within 10-ft of levee toe.

11/17/2011 Privacy fence is located at the toe.

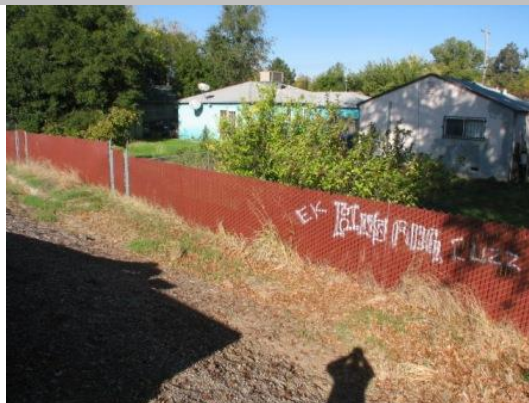
Photo 1 of 1 : SP_2019_NA0001_58_14_20190307_00013.jpg

LM Start	1.83	Rating **	U	Issue No.	14
LM End	1.83	Issue Type +	En	Location *	LS
Category	Earthen Levee			GPS Latitude/Longitude	
				Start	End
Item	Encroachments			38.628303 °	38.628303 °
				-121.437530 °	-121.437530 °
DWR ID	DWR_NA0001_07_s_2012_14				
Comment Code					
FE : Fence					
Inspector Comment					
Chain link privacy fence is within 10-ft of levee toe.

Fall 2009 photo of privacy fence within 10-ft of the levee toe obstructs visibility and access.

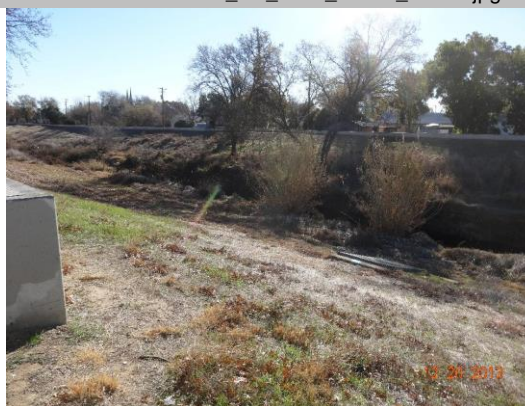
Photo 2 of 3 : UCIP_SP_2019_29326_54318.jpg

View of waterward slope.

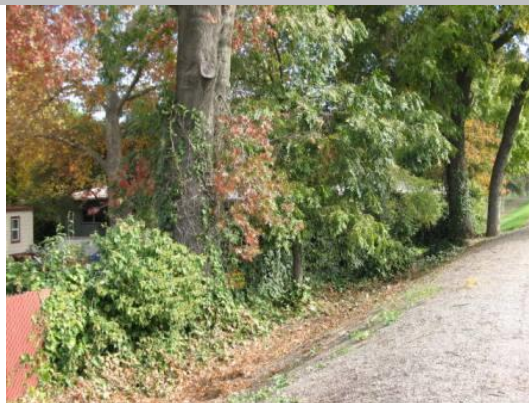
Photo 1 of 2 : SP_2019_NA0001_58_15_20190307_00014.jpg

LM Start	1.84	Rating **	U	Issue No.	15
LM End	1.84	Issue Type +	En	Location *	LS
Category	Earthen Levee			GPS Latitude/Longitude	
				Start	End
Item	Vegetation			38.628295 °	38.628295 °
				-121.437282 °	-121.437282 °
DWR ID	DWR_NA0001_07_s _ 2012_15				
Comment Code					
V6 : Landscaping					
Inspector Comment					
Dense ivy growing on chain link fence within 10-ft of levee toe.

11/17/2011 Dense vegetation at the toe.

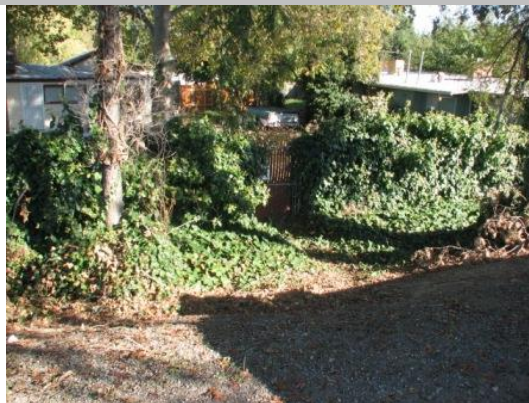
Photo 2 of 2 : SP_2019_NA0001_58_15_20190307_00015.jpg

LM Start	1.84	Rating **	U	Issue No.	15 (cont)	
LM End	1.84	Issue Type +	En	Location *	LS	
Category	Earthen Levee			GPS Latitude/Longitude		
				Start		End
Item	Vegetation			38.628295 °		38.628295 °
				-121.437282 °		-121.437282 °
DWR ID	DWR_NA0001_07_s _ 2012_15					
Comment Code						
V6 : Landscaping						
Inspector Comment						
Dense ivy growing on chain link fence within 10-ft of levee toe.

Fall 2009 photo of dense ivy and fence obstruct visibility and access.

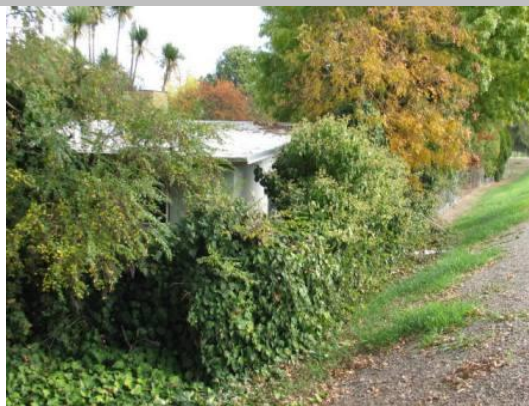
Photo 1 of 1 : SP_2019_NA0001_58_16_20190307_00016.jpg

LM Start	1.86	Rating **	U	Issue No.	16
LM End	1.86	Issue Type +	En	Location *	LS
Category	Earthen Levee			GPS Latitude/Longitude	
				Start	End
Item	Vegetation			38.628262 °	38.628262 °
				-121.436985 °	-121.436985 °
DWR ID	DWR_NA0001_07_s _ 2012_16				
Comment Code					
V6 : Landscaping					
Inspector Comment					
Dense ivy and trees along chain link fence on levee toe. Large building is within 10-ft of levee toe.

11/17/2011 Vegetation and building obstruct visibility and access to the levee toe.

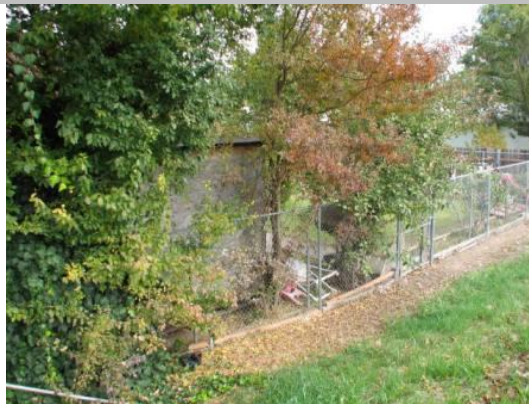
Photo 1 of 1 : SP_2019_NA0001_58_22_20190307_00019.jpg

LM Start	1.87	Rating **	U	Issue No.	22
LM End	1.87	Issue Type +	En	Location *	LS
Category	Earthen Levee			GPS Latitude/Longitude	
				Start	End
Item	Encroachments			38.628318 °	38.628318 °
				-121.436794 °	-121.436794 °
DWR ID	DWR_NA0001_07_s _ 2012_22				
Comment Code					
BU : Building					
Inspector Comment					
Wooden shed and landscaping along chain link fence within 10-ft of levee toe.

11/17/2011 Building is too close to the levee toe and obstructs visibility and access.

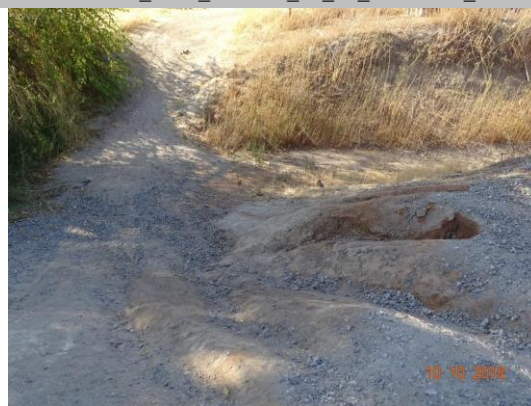
Photo 1 of 1 : SP_2019_NA0001_59_14_20190307_00010.jpg

LM Start	0.29	Rating **	M	Issue No.	14
LM End	0.29	Issue Type +	Ma	Location *	LS
Category	Earthen Levee			GPS Latitude/Longitude	
				Start	End
Item	Slope Stability			38.668196 °	38.668196 °
				-121.442171 °	-121.442171 °
DWR ID	DWR_NA0001_08_f_2018_14				
Comment Code					
S2 : Repair the levee slope damaged by foot traffic and prevent access where possible.					
Inspector Comment					
Repair slope damage from foot traffic and erosion around gate.

View of slope damage near gate on an oversized section of levee. Fall 2018

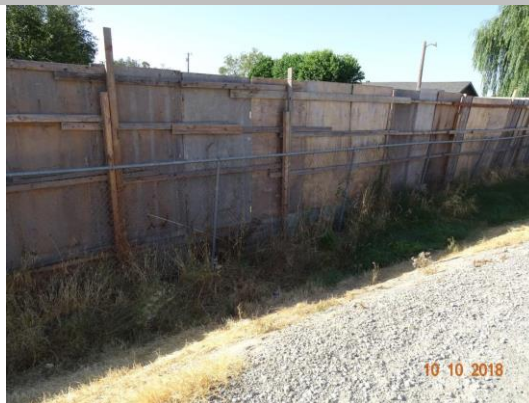
Photo 1 of 1 : SP_2019_NA0001_59_13_20190307_00009.jpg

LM Start	0.31	Rating **	U	Issue No.	13
LM End	0.32	Issue Type +	En	Location *	LS
Category	Earthen Levee			GPS Latitude/Longitude	
				Start	End
Item	Encroachments			38.668164 °	38.668152 °
				-121.441870 °	-121.441639 °
DWR ID	DWR_NA0001_08_f_2018_13				
Comment Code					
FE : Fence					
Inspector Comment					
Raised wooden fence blocks visibility along levee easement.

View of raised wooden fence that blocks visibility along levee easement. Fall 2018

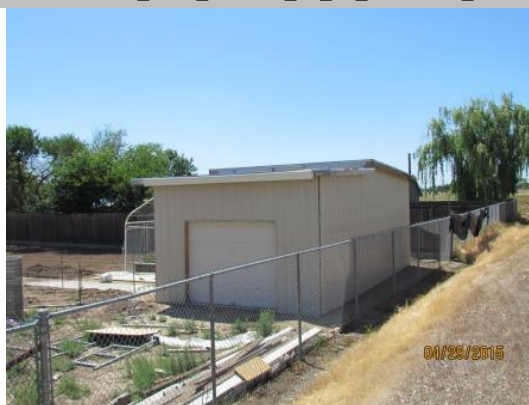
Photo 1 of 1 : SP_2019_NA0001_59_15_20190307_00011.jpg

LM Start	0.33	Rating **	U	Issue No.	15
LM End	0.33	Issue Type +	En	Location *	LS
Category	Earthen Levee			GPS Latitude/Longitude	
				Start	End
Item	Encroachments			38.668135 °	38.668135 °
				-121.441563 °	-121.441563 °
DWR ID	DWR_NA0001_08_f_2013_15				
Comment Code					
BU : Building					
Inspector Comment					
A building is located within 10 feet of the landside levee toe.

View of the building within 10 feet of landside levee toe, facing downstream. Spring 2015
